STATUS OF F/A-22

FULL SCALE FATIGUE TEST

2004 USAF ASIP Conference

Shery Welsh, Lead DADT Engineer

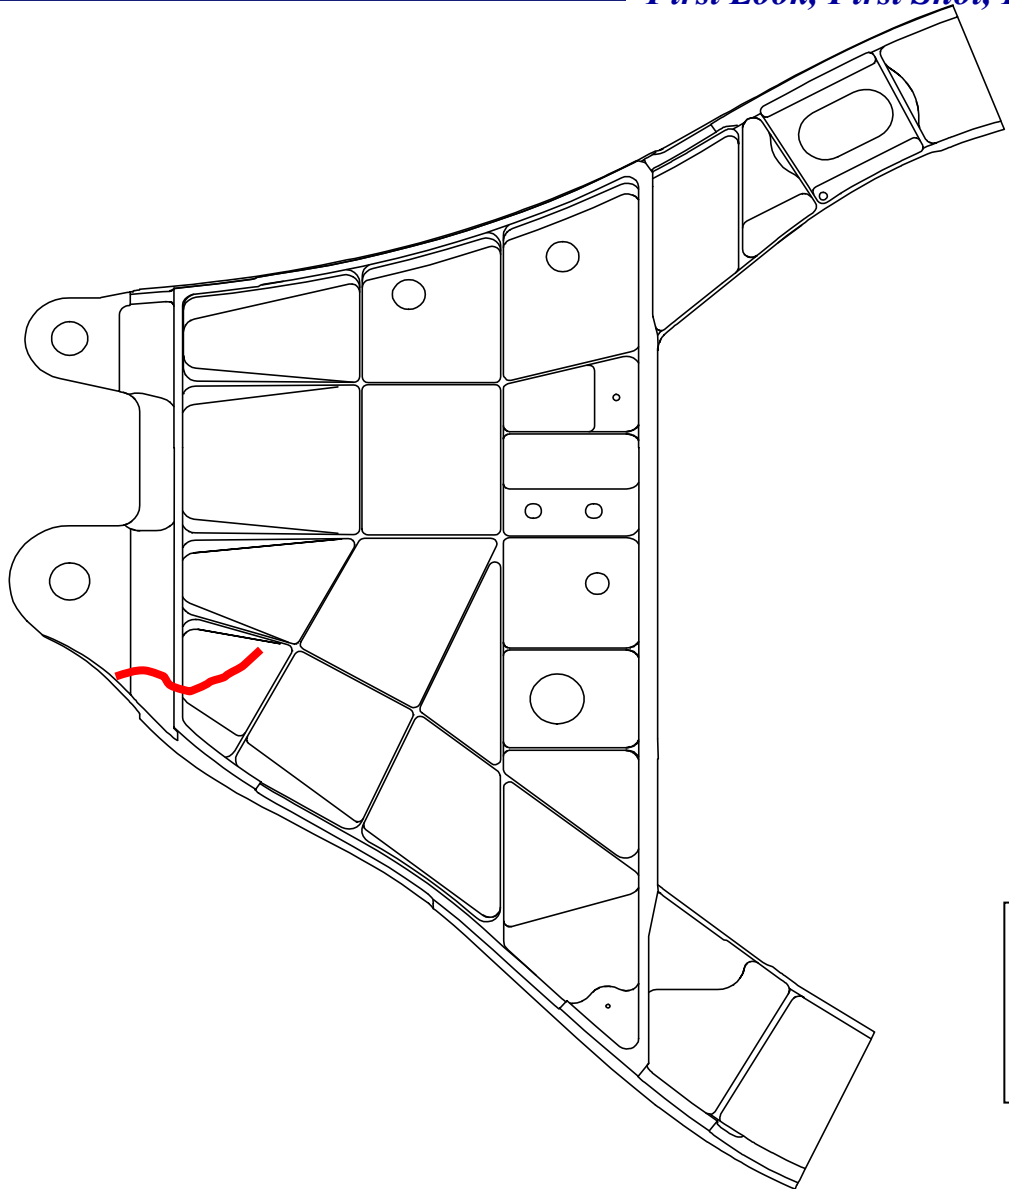
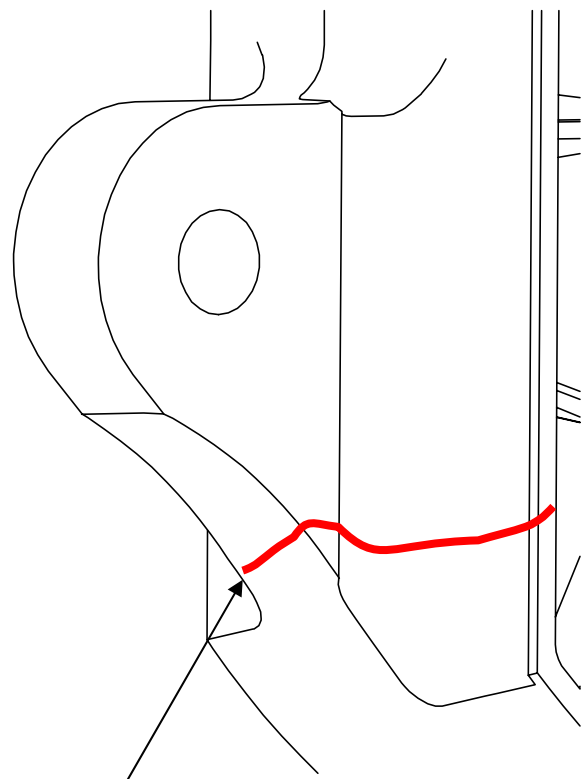
LHS Forward Boom Frame 2

The crack wraps around the lug to the thickened up area ending at a thin section

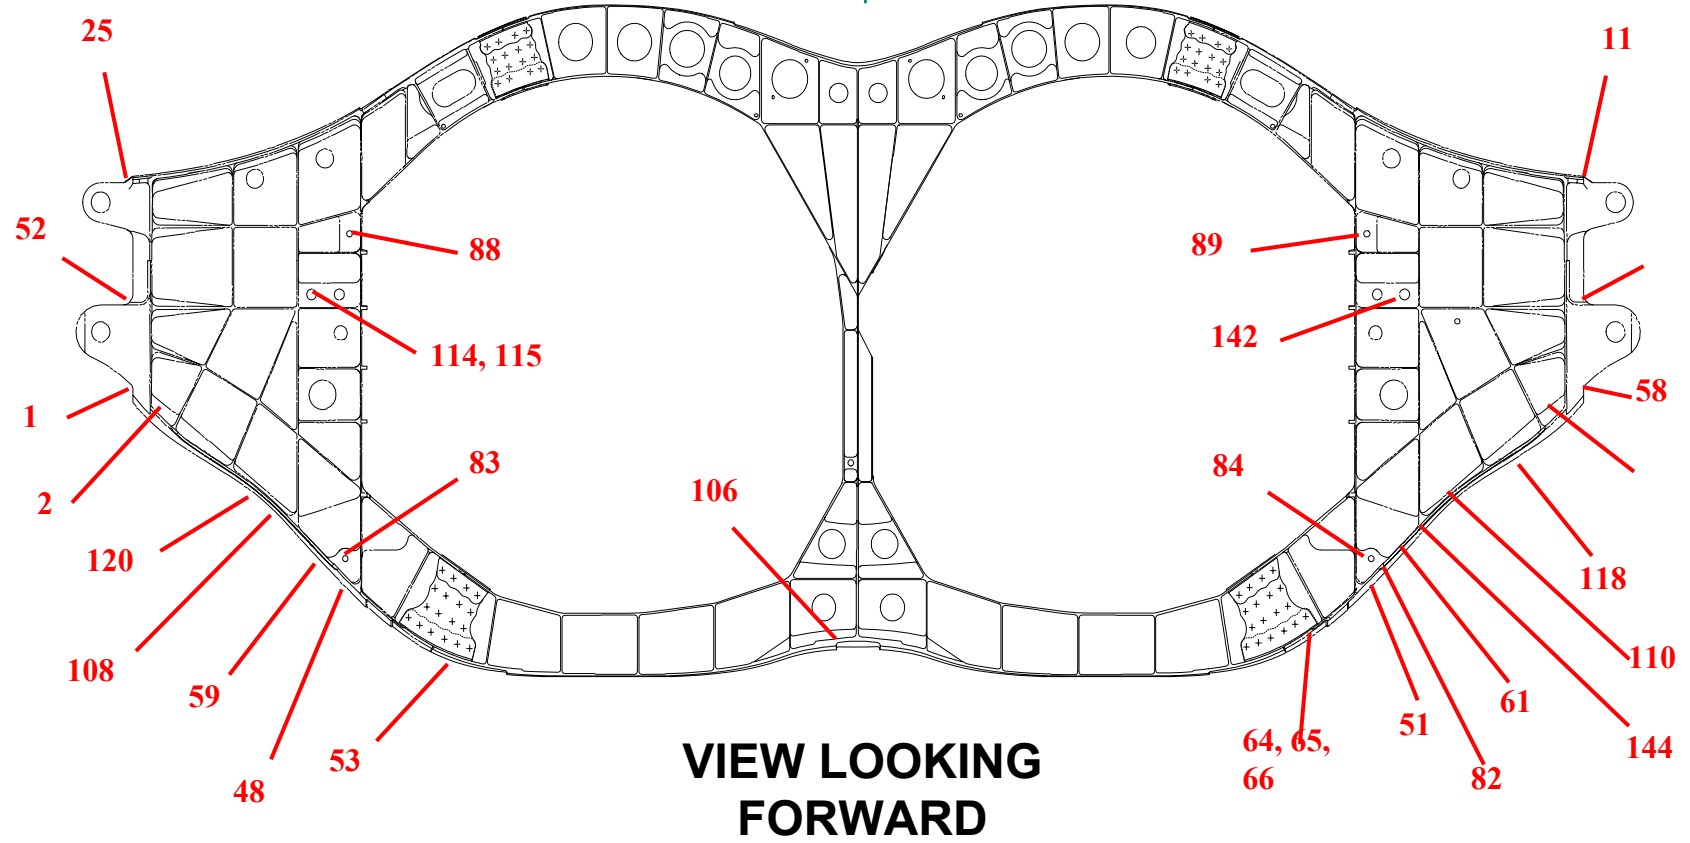
FS 657 Frame 2

Crack Locations Identified

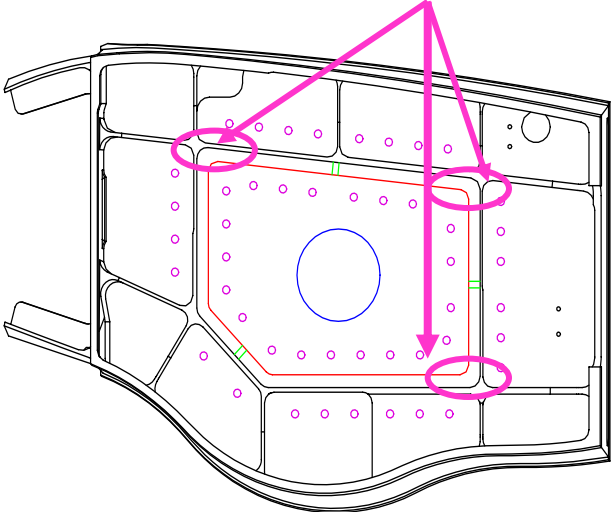
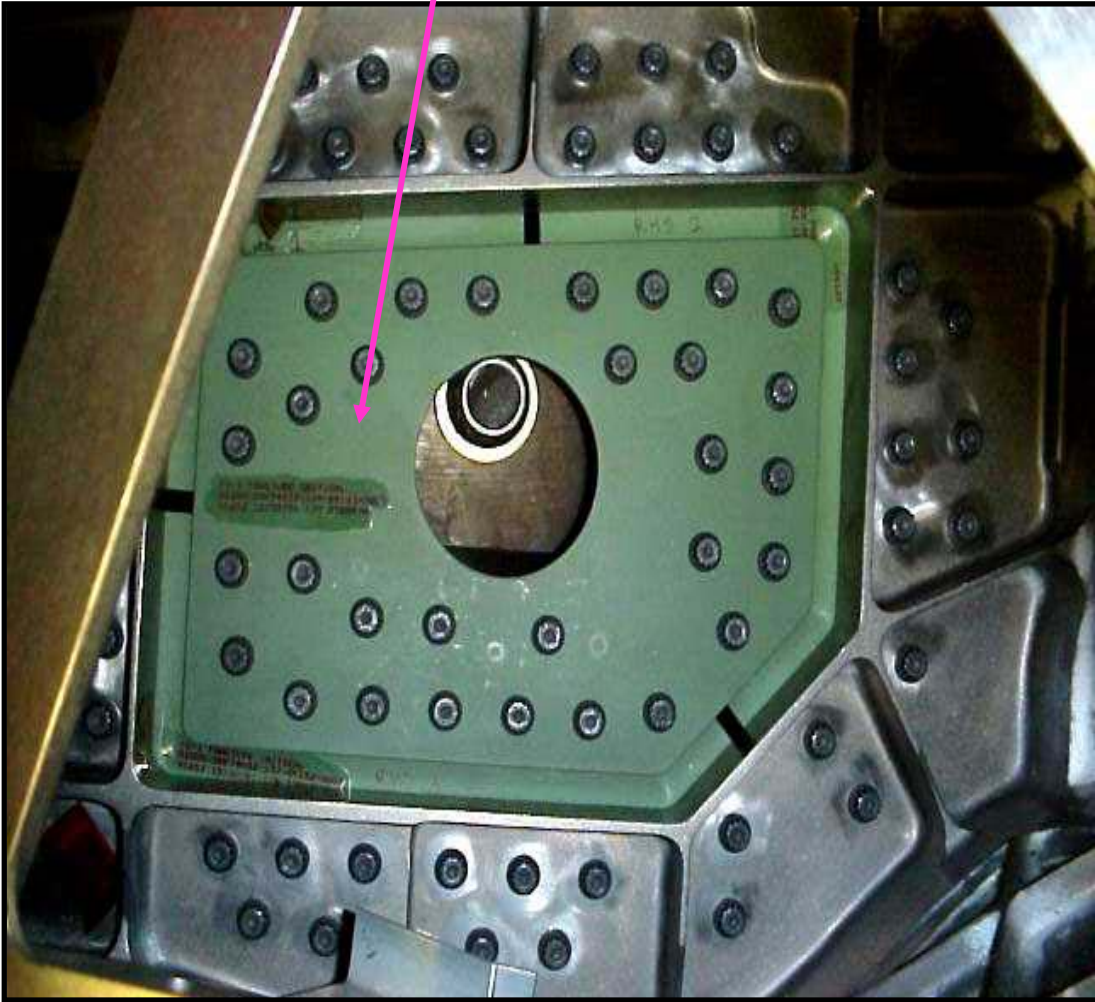
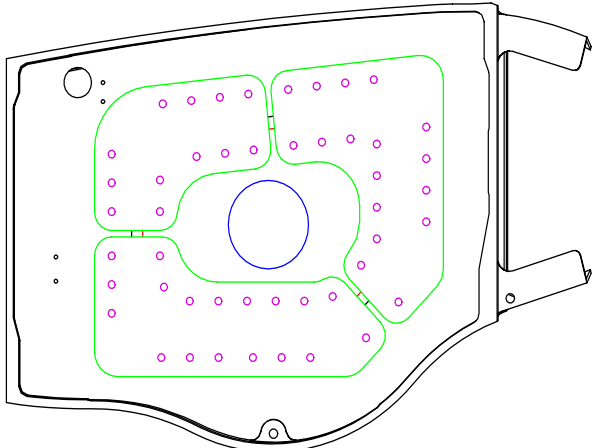
Aft Boom Frame 4 Repair

Crack locations

Secondary shear plate
